NATIONAL DAM INSPECTION PROGRAM. JEANNETTE DAM (NDSI.D.-PA-0048--ETC(U)

PHASE I REPORT
NATIONAL DAM INSPECTION PROGRAM

Jeannette Dam: NDS I.D. No. PA-00486

Owner: Mrs. Helen Indyk 12 104p.
State Located: Pennsylvania (PennDER I.D. No. 65-9)
County Located: Westmoreland
Stream: Tributary of Brush Creek
Inspection Date: 9 March 1979 11 Apr 79
Inspection Team: GAI Consultants, Inc.
570 Beatty Road
Monroeville, Pennsylvania 15146

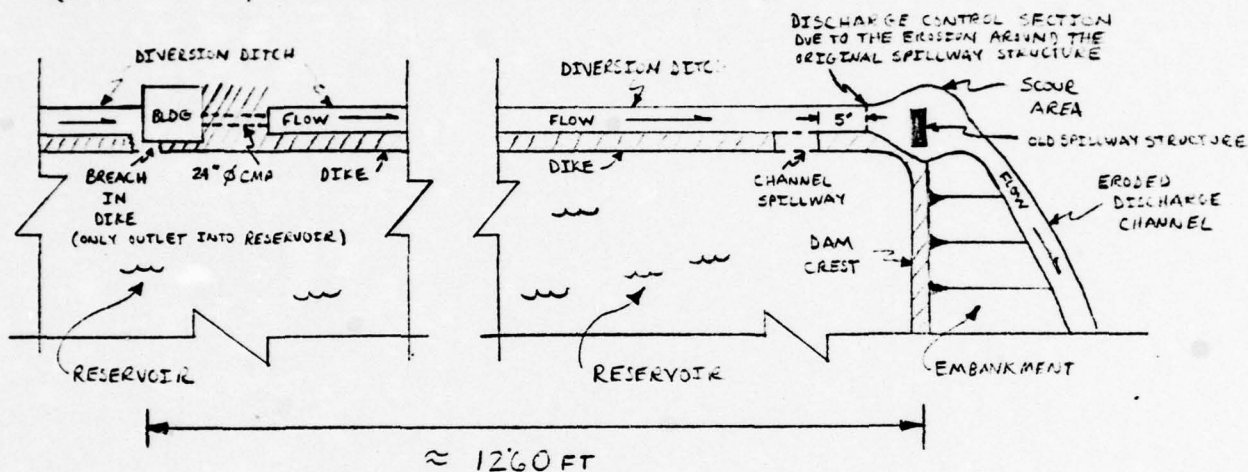
THE CONTROL SECTION IS VERY UNSTABLE SINCE IT IS
 FOUNDED IN EARTH AND IS A PRODUCT OF THE EROSION
 AROUND THE ACTUAL SPILLWAY STRUCTURE. HOWEVER, IT WILL
 BE ASSUMED THAT THE SECTION IS STABLE IN THIS ANALYSIS.

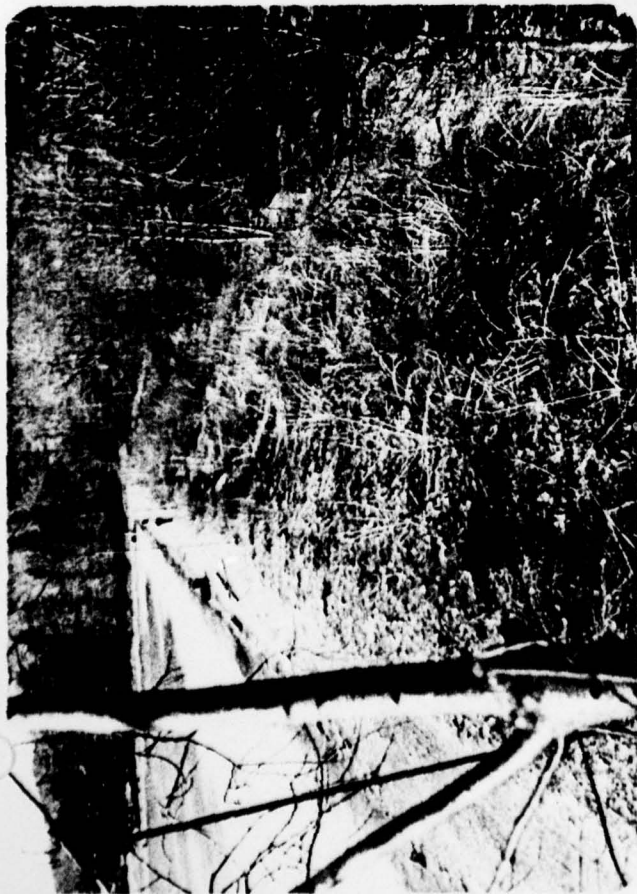
PHOTOGRAPH 1 View of Jeannette Dam from the right abutment.

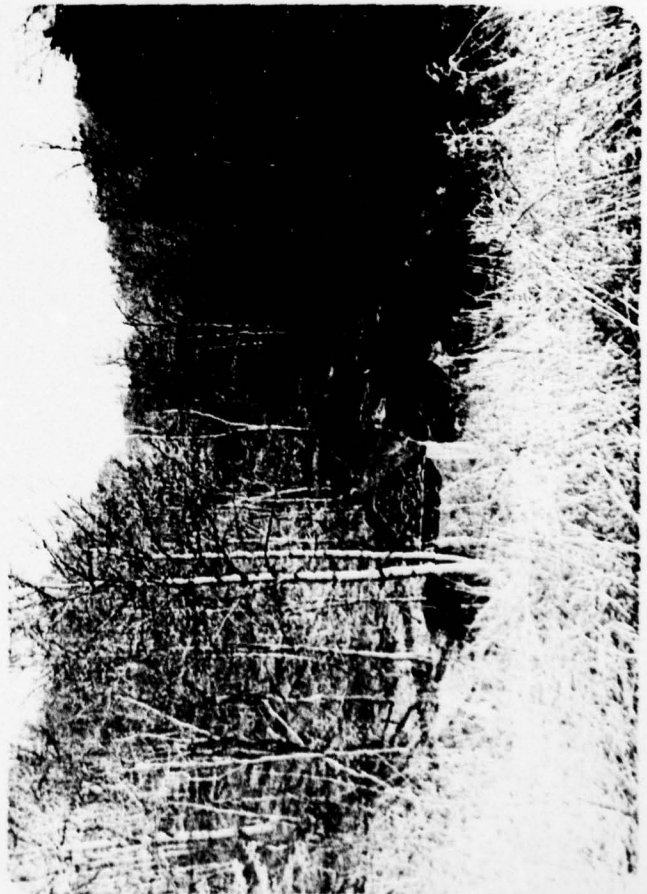
PHOTOGRAPH 3 View from crest of dam looking downstream.

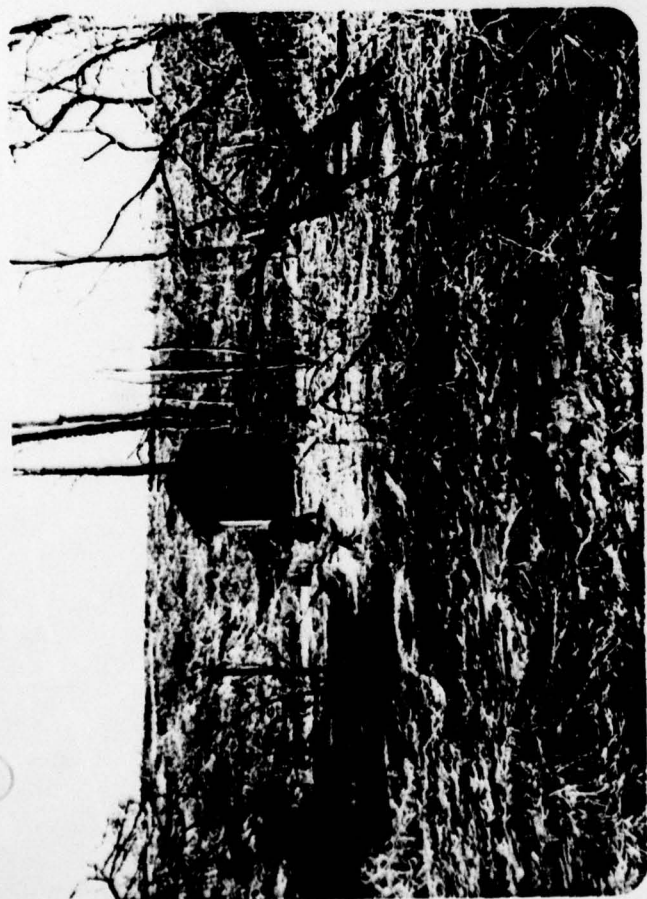
13

3. Outlet Works. Based on interviews and observations made during the inspection, the outlet works at Jeannette Dam appear to be inoperable. The present owner knows little, if anything, about the system and has never maintained it. The gate house structure (see Photograph 13) is dilapidated. Valves, where visible, are heavily corroded, and the valve pit is flooded presumably by a continual flow emanating from a 3/4-inch broken pipe of unknown origin within the valve chamber. In addition, there is an apparent vault or valve pit located just downstream of the gate house, also flooded, of which no records are available. The outlet end of the blowoff line could not be located and is presumably also buried by sediment. The owner's representative indicated that the supply line had been disconnected and capped by the previous owner at the time of transfer.

f. Restoration of the outlet works. Included should be provisions for valving the outlet conduits at both the upstream and downstream ends and for renovating and repairing the present gate house.
